A Supplemental Report Issued Following Hurricane Harvey

# Examination of Selected Assertions by U.S. EPA in the Proposed Remedial Action Plan for the San Jacinto River Waste Pits Superfund Site

**Doug Shields, Jr., Ph.D., P.E., D.WRE**

October 6, 2017

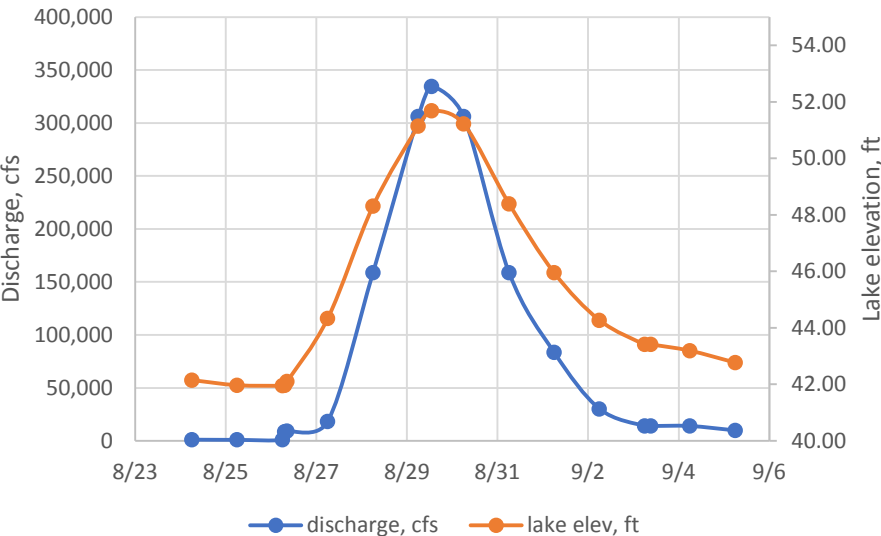
a. Lake Houston Dam discharges and Lake Houston stage from Coastal Water Authority (CWA).

Discharge records for the Lake Houston Dam (see Figure 2a) indicated a peak discharge of 334,400 cubic feet per second on August 29, 2017. This discharge is about 82% of the value computed for the 0.2% chance (500-year return interval event) for this location (FEMA 2107). Stage measurements by the United States Geological Survey (USGS) and posted to the web by the National Weather Service at the U. S. Highway 90 bridge were incomplete, but indicated that the peak stage exceeded 28.5 ft, some 18.5 ft above flood stage (Figure 2b), and stage data collected by the USGS at the I-10 bridge which is immediately south of the TCRA Armored Cap, indicated that passage of the storm produced peak stages 12 ft above the base flow stage (Figure 2c).

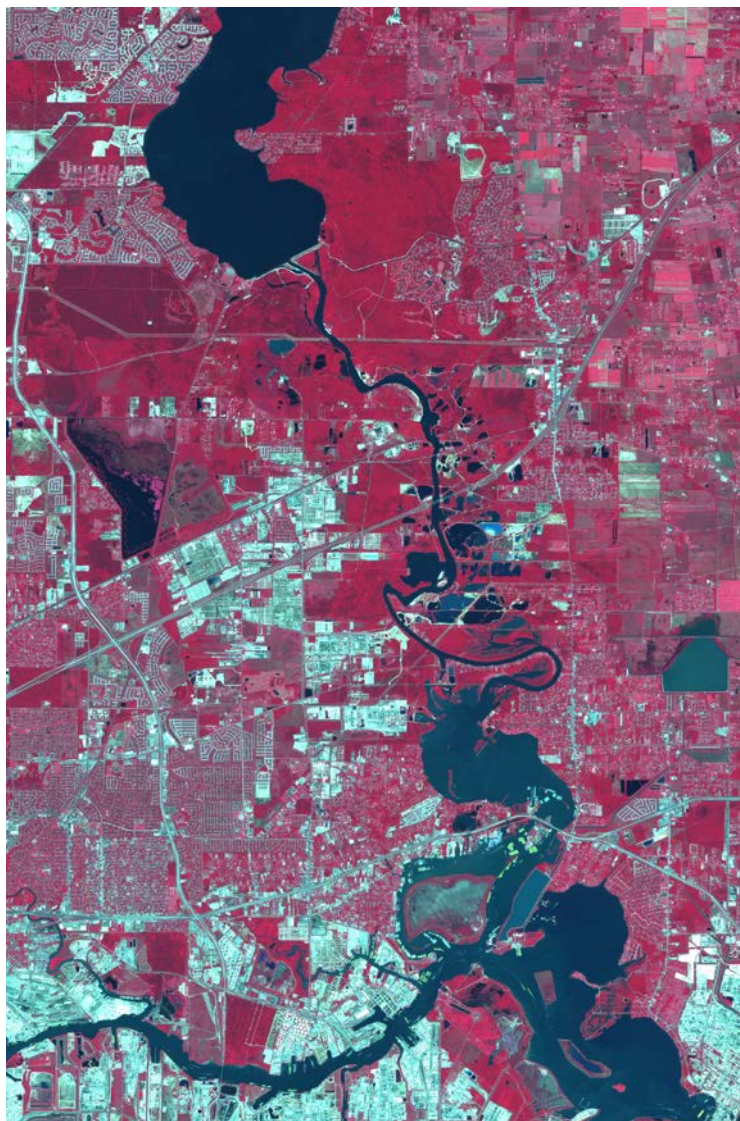
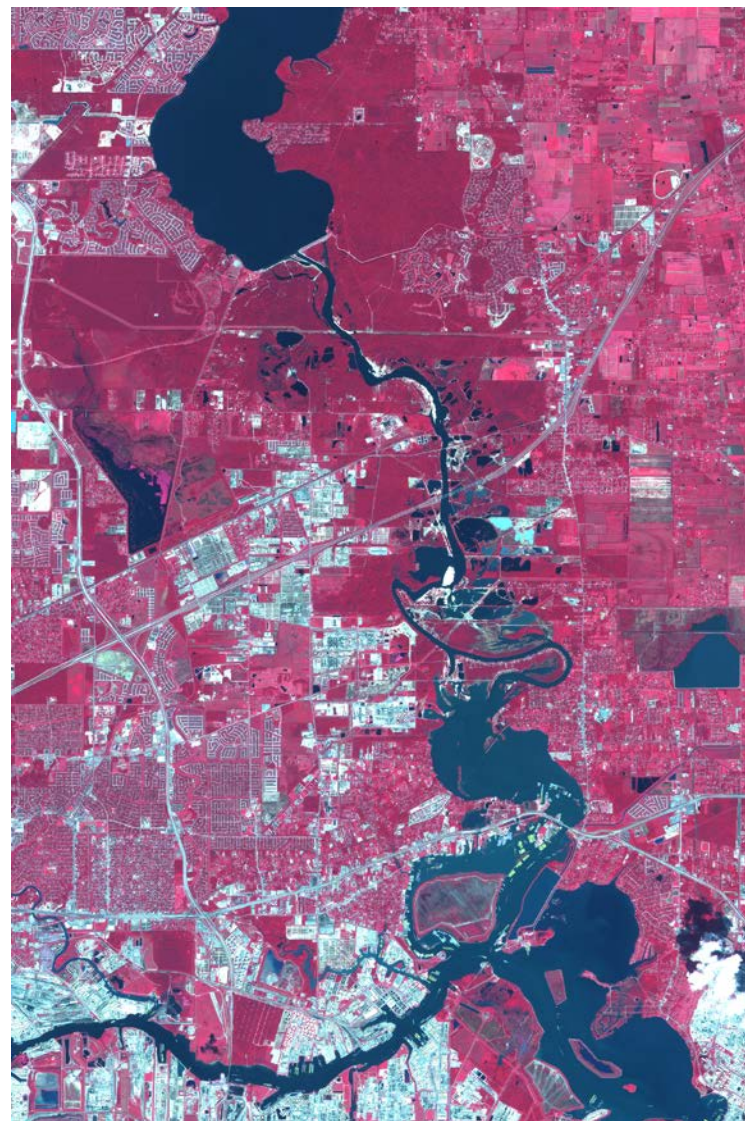
a. Lake Houston Dam to Buffalo Bayou

Comparison of the color infrared images confirmed impressions made by the on-the-ground visual inspection (Figures 3 and 4). Channel activity was limited to a reach beginning about 2.3 miles below the Lake Houston Dam to about 5.3 miles below the dam and that reach begins about 1.9 miles above the existing TCRA Armored Cap (straight-line distances). Fresh sediment deposits were more common than erosion; both along the channel margins, in the form of mid-channel bars, and in overbank areas subjected to flow (Figures 3a-d and 4a-d). Floodplain erosion and deposition associated with overbank flows existed in the same locations (Rio Villa in Banana Bend oxbow and Highland Shores in Banana Bend) as for the 1994 flood (Figure 3c), which were described in my January 2017 Report. There was also some floodplain erosion associated with overbank flow about 1.25 miles due east of the TCRA Armored Cap (Figure 3d) that was noted in the on-the-ground reconnaissance (Figure 1). However, as in 1994, eroded overbank channels did not capture river baseflow, and the river returned to its pre-flood channel as the flood receded (Figure 3a).

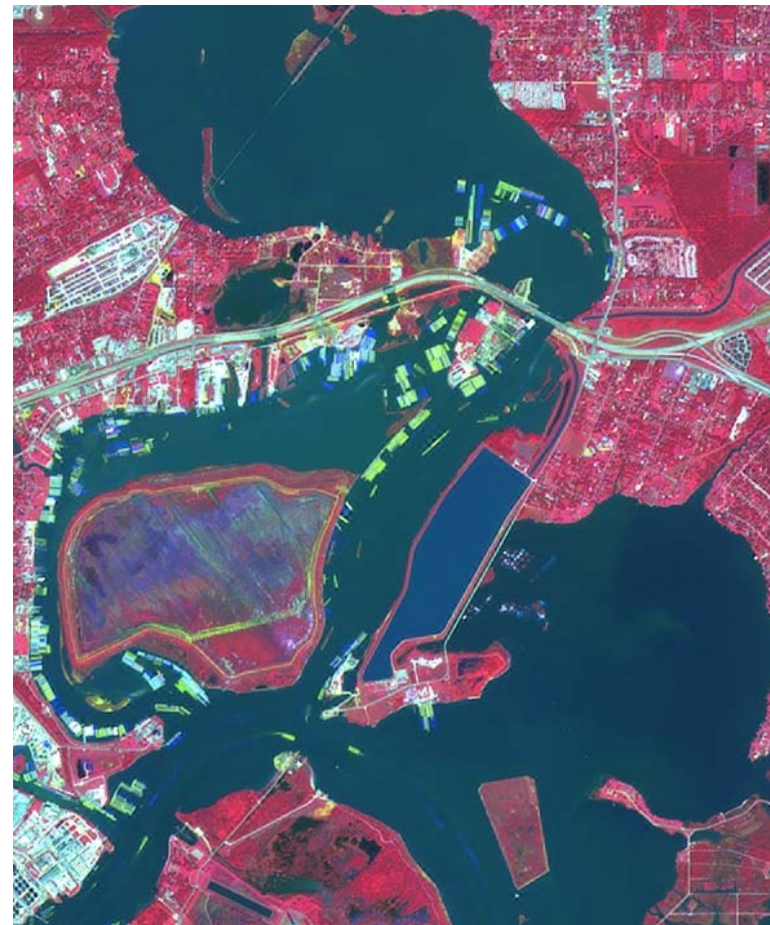
d. Bear Lake to Buffalo Bayou

Highway 90 bridge, about 5.2 miles northwest of the existing TCRA Armored Cap (Figure 6b and c). The lack of erosion and deposition in the reach in which the Site is located (Figures 3d and 4d) was consistent with output from a 2D hydrodynamic computer model that was used to simulate passage of the Hurricane Harvey event (hindcasting). Maximum simulated shear stresses along the shorelines and banks in this reach during the Hurricane Harvey event were generally well below  $1 \text{ Pa} = 0.02 \text{ lb/sq ft}$  (Figure 7), implying that they were less than levels that would initiate erosion of floodplain soils (Fischenich 2001) and generally below reported levels needed to erode cohesive bank sediments (Clark and Wynn 2007, Enlow et al. 2017).
